B Thermal Inspection Report

B Electric Pty.Ltd

Client and Site Contact	100 Smith St, Brisbane Barry Brown
Location of Equipment	Level 1 Plant Room Mechanical Services Switchboard
Equipment	Pump 1 White Phase Fuse
Time of Image	10.30 AM
Date of Image	3/3/2017
Report No.	2
Thermographer	Mark Blanch

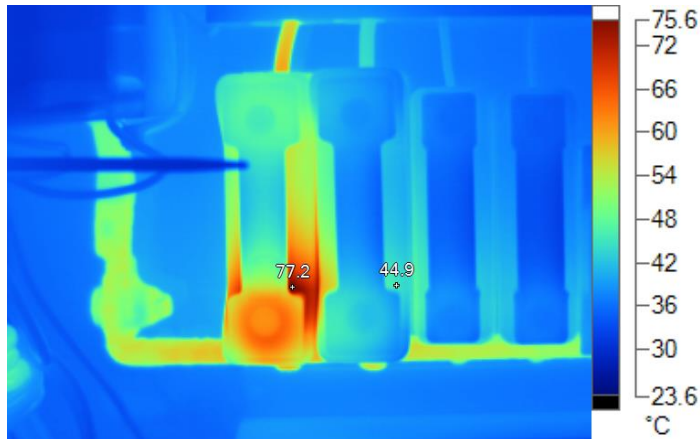
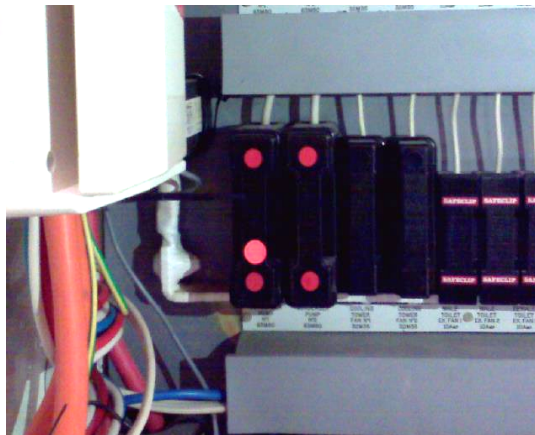
Hot Spot Temperature	77.2°C
Reference Temperature	44.9°C
Thermographers Comments	Heat signature indicates loose internal fuse contacts.
Repair Date / Comments	Replace fuse base and fuse.
Next Survey Due	March 2018
