B Thermal Inspection Report

B Electric Pty.Ltd

Client and Site Contact	100 Smith St, Brisbane Barry Brown
Location of Equipment	Level 2 Electrical Riser Distribution Board 2
Equipment	Tenant Supply Load Shed Contactor "Power"
Time of Image	10.30 AM
Date of Image	3/3/2017
Report No.	3
Thermographer	Mark Blanch

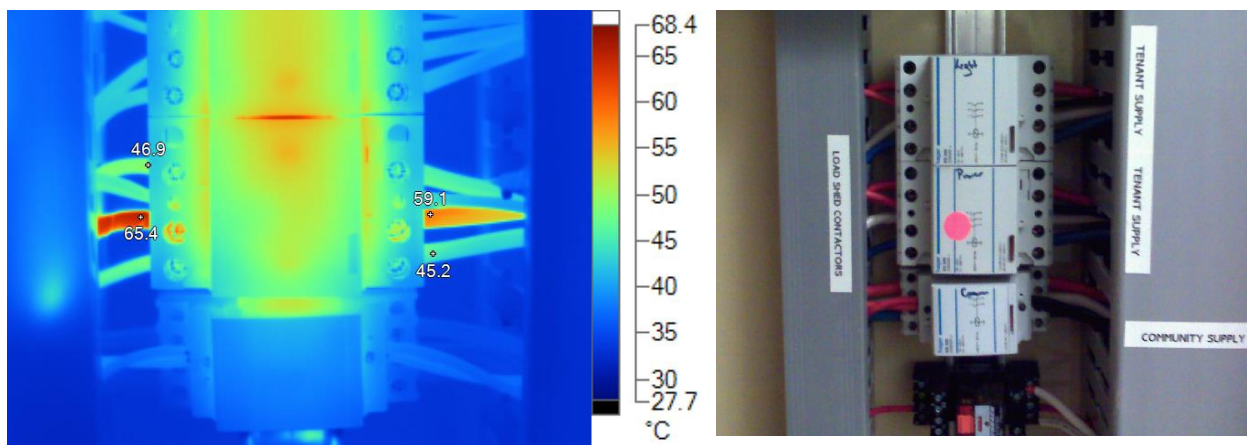
Hot Spot Temperature	65.4°C
Reference Temperature	45.2°C
Thermographers Comments	Heat signature indicates loose cable connections and an unbalanced load. Load at time of inspection was, Red Phase 12 Amps; White Phase 26 Amps; Blue Phase 11 Amps.
Repair Date / Comments	Investigate and re-balance load as required.
Next Survey Due	March 2018
